CAA 112(r) INSPECTION REPORT

Iowa Premium
3777 L Avenue
Tama, Iowa
County: Tama
641-484-2220
Process: Anhydrous ammonia refrigeration

September 9, 2015
Case No.: 15IA0909
RMP No.: 1000 0000 5843
FRS No.: 1100 0041 4873
High Risk: No
Program Level: 3

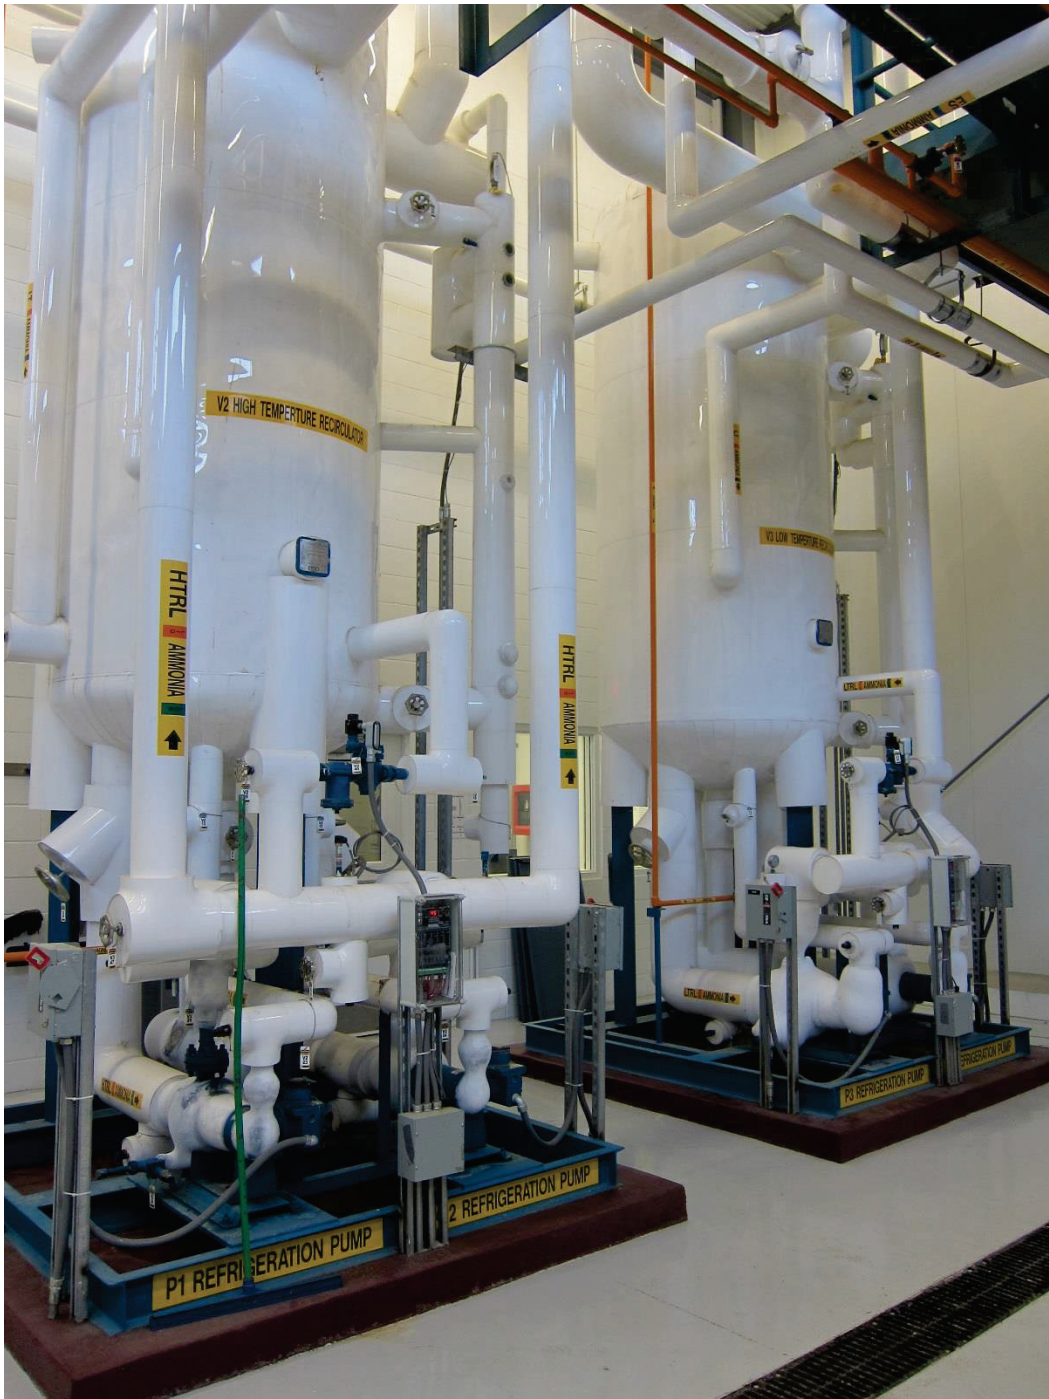
CASE NO. 15IA0909 Direction: <i>Not recorded</i>	DESCRIPTION	This photograph shows recirculator vessels of the facility’s “low-side” anhydrous ammonia refrigeration system.	1
	FACILITY	Iowa Premium – Low-Side Refrigeration System	Date
	PHOTOGRAPHER	Robert Monnig	9/9/15

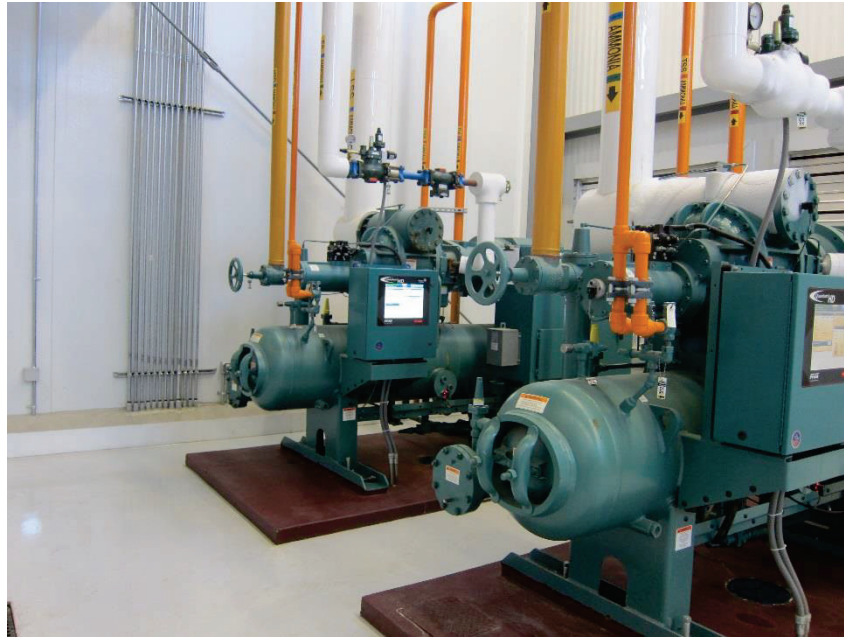
CASE NO. 15IA0909 Direction: <i>Not recorded</i>	DESCRIPTION	This photograph shows compressors of the low-side system.	2
	FACILITY	Iowa Premium – Low-Side Refrigeration System	Date
	PHOTOGRAPHER	Robert Monnig	9/9/15

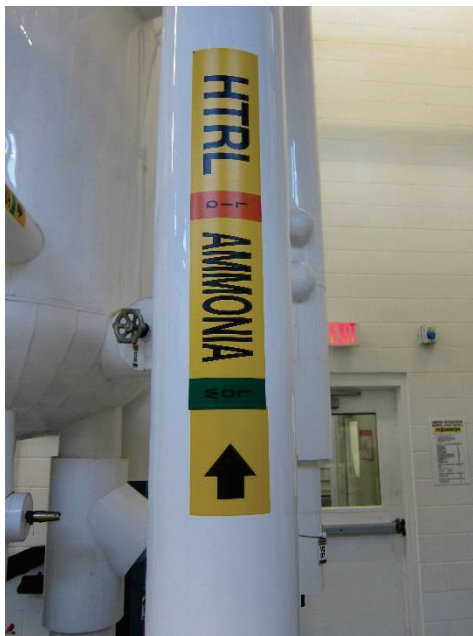
CASE NO. 15IA0909 Direction: <i>Not recorded</i>	DESCRIPTION	This photograph shows typical labeling on piping.	3
	FACILITY	Iowa Premium – Low-Side Refrigeration System	Date
	PHOTOGRAPHER	Robert Monnig	9/9/15

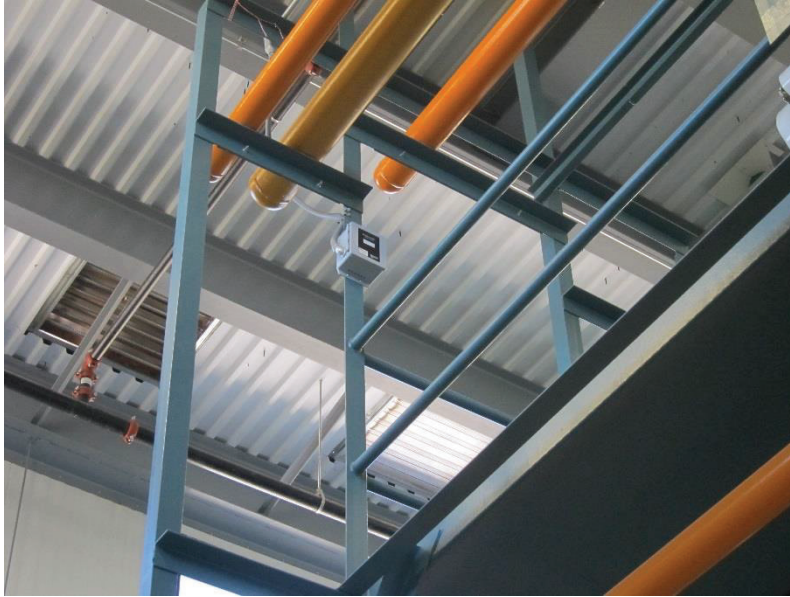
CASE NO. 15IA0909 Direction: <i>Not recorded</i>	DESCRIPTION	This photograph shows an anhydrous ammonia sensor (box at center) in low-side engine room.	4
	FACILITY	Iowa Premium – Low-Side Refrigeration System	Date
	PHOTOGRAPHER	Robert Monnig	9/9/15

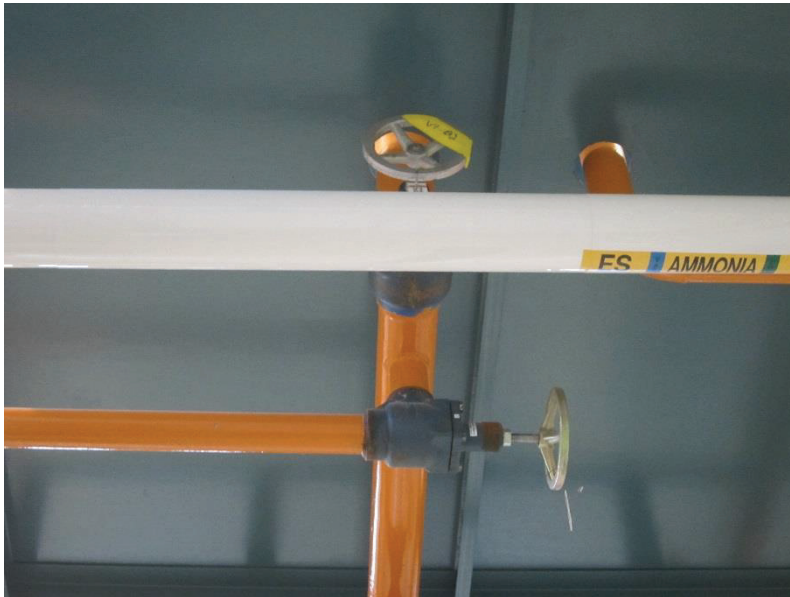
During the walk-through of the high- and low-side refrigeration systems, I had asked Mr. Marks and Mr. Behounek to identify the “king valves” of each system (king valves can typically function as shut-off valves during emergencies). For the low-side system, Mr. Behounek identified a valve beneath an overhead platform (supporting a receiver vessel) as the king valve for the system. I took a photograph of the valve (see Appendix A, Item 5, Photograph 5) and noted that the valve was identified only by a piece of tape marked “VI-02” (no marking indicated the valve was a king valve or shutoff valve). Because the IIAR Bulletin No. 109 “Guidelines for IIAR Minimum Safety Criteria for a Safe Ammonia Refrigeration System” specifies that the main shut-off valve (“king valve”) should be identified with a prominent sign having letters sufficiently large to be easily read, I identified the following preliminary finding during my post-inspection review:

4. **The facility had not followed the generally accepted and good engineering practice of prominently identifying the main shut-off valve (“king valve”) of the facility’s “low side” anhydrous ammonia refrigeration system (40CFR 68.73(e)).**

CASE NO. 15IA0909 Direction: Up	DESCRIPTION	This photograph shows the valve that Mr. Behounek indicated was the king valve for the low-side system (see valve with yellow tape). This valve was located on the underside of an elevated platform.	5
	FACILITY	Iowa Premium – Low-Side Refrigeration System	Date
	PHOTOGRAPHER	Robert Monnig	9/9/15

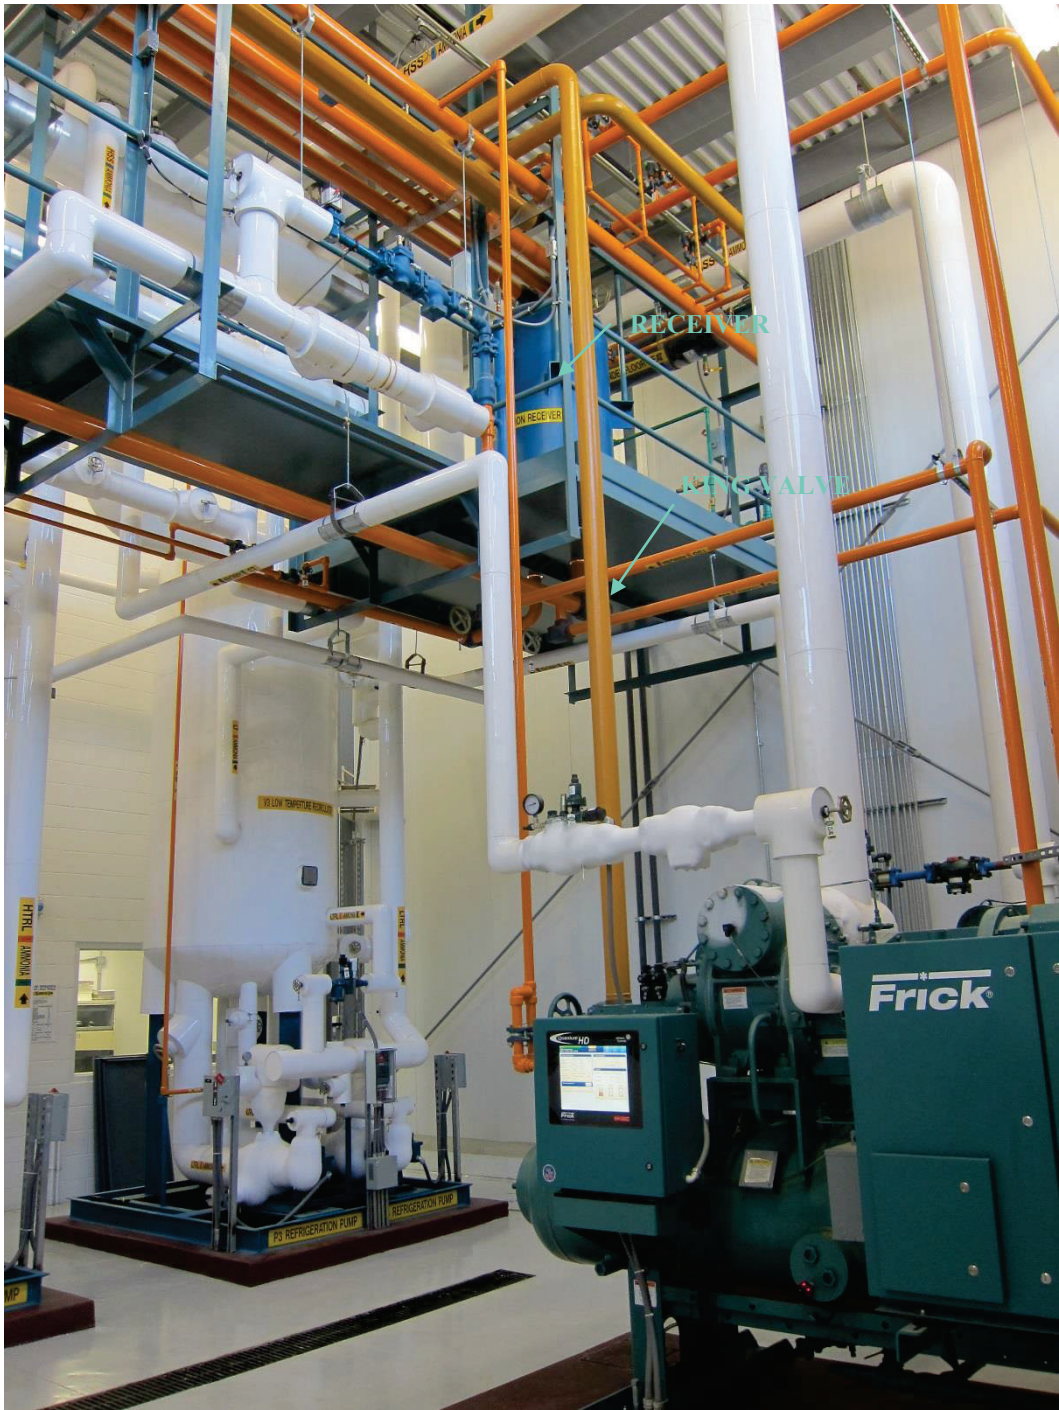
CASE NO. 15IA0909 Direction: North	DESCRIPTION	This photograph shows the arrangement of the king valve beneath the overhead platform that supports the receiver vessel.	6
	FACILITY	Iowa Premium – Low-Side Refrigeration System	Date
	PHOTOGRAPHER	Robert Monnig	9/9/15

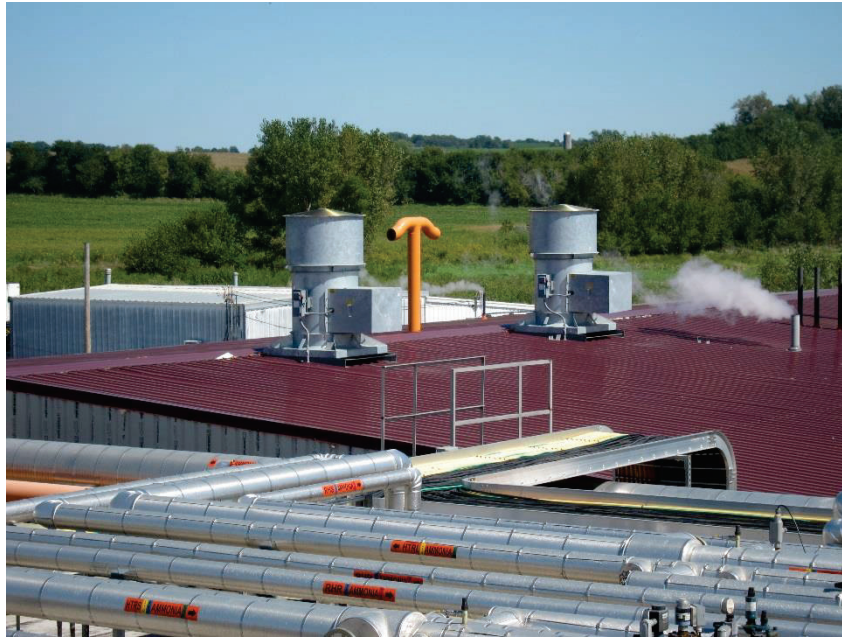
CASE NO. 15IA0909 Direction: East	DESCRIPTION	This photograph shows anhydrous ammonia piping and a relief vent (see vertical orange piping) on the facility's roof.	7
	FACILITY	Iowa Premium – High-Side Refrigeration System	Date
	PHOTOGRAPHER	Robert Monnig	9/9/15

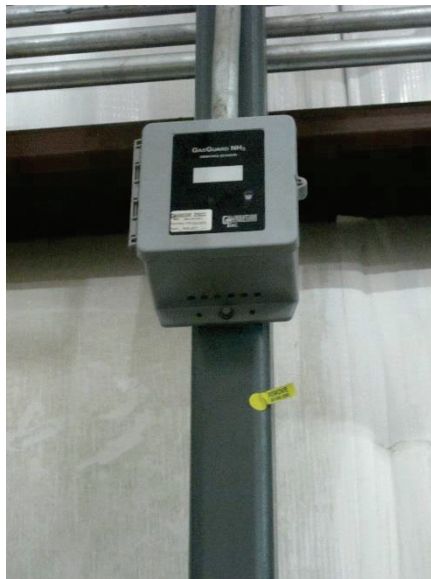
CASE NO. 15IA0909 Direction: East	DESCRIPTION	This photograph shows an anhydrous ammonia sensor in the engine room of the “high-side” anhydrous ammonia system.	8
	FACILITY	Iowa Premium – High-Side Refrigeration System	Date
	PHOTOGRAPHER	Robert Monnig	9/9/15

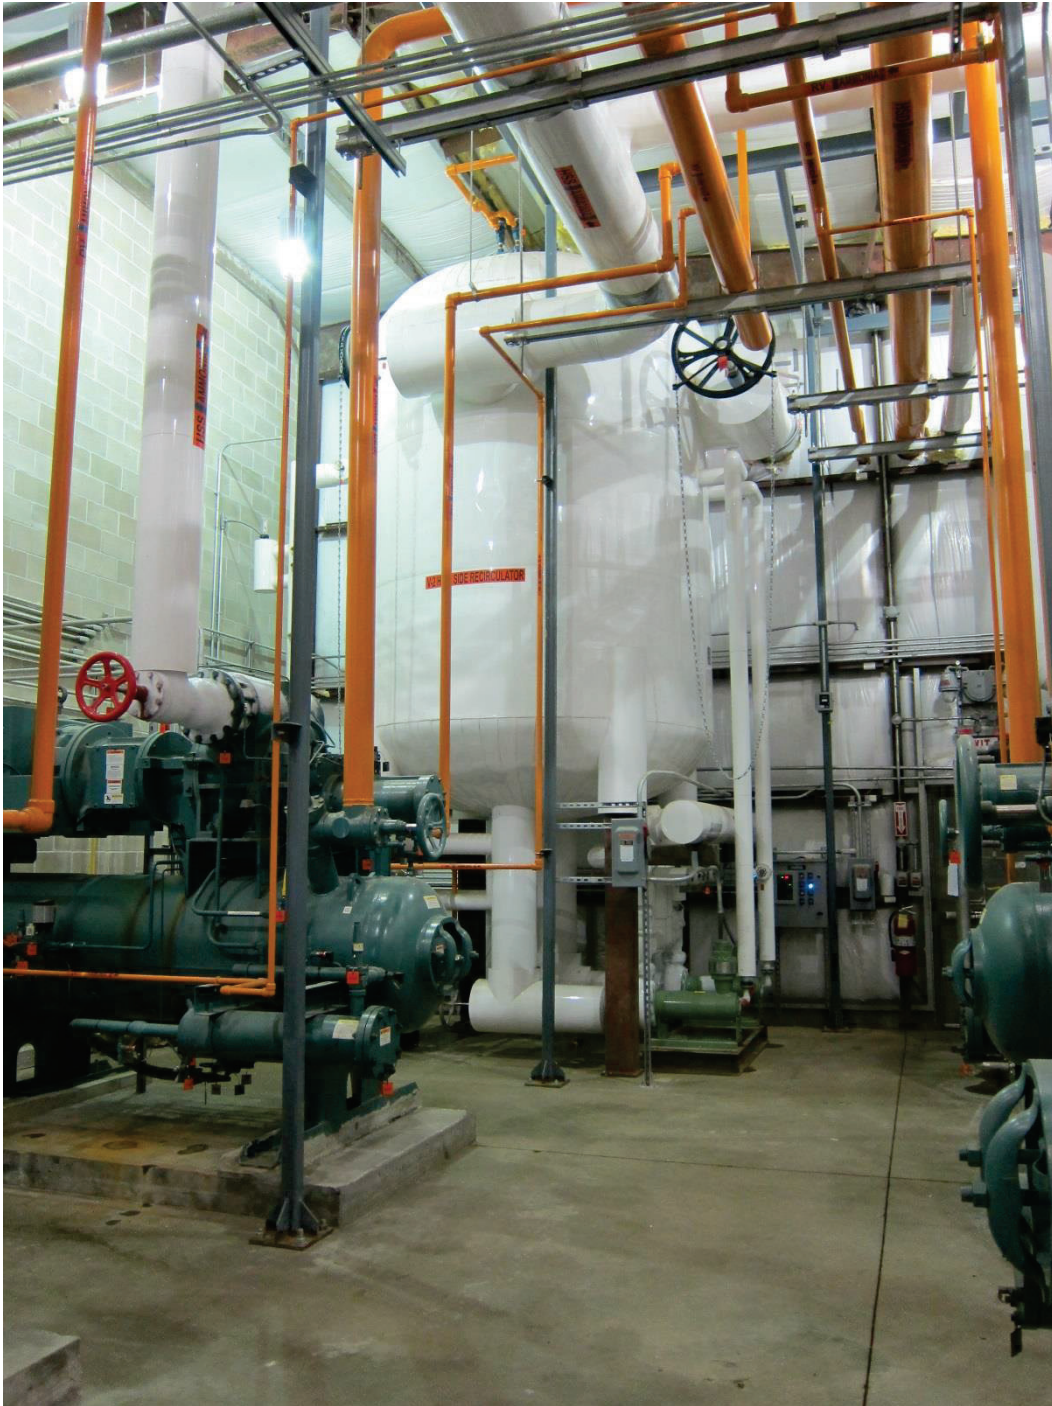
CASE NO. 15IA0909 Direction: <i>Not recorded</i>	DESCRIPTION	This photograph shows a recirculator vessel and compressors in the engine room of the high-side system.	9
	FACILITY	Iowa Premium – High-Side Refrigeration System	Date
	PHOTOGRAPHER	Robert Monnig	9/9/15

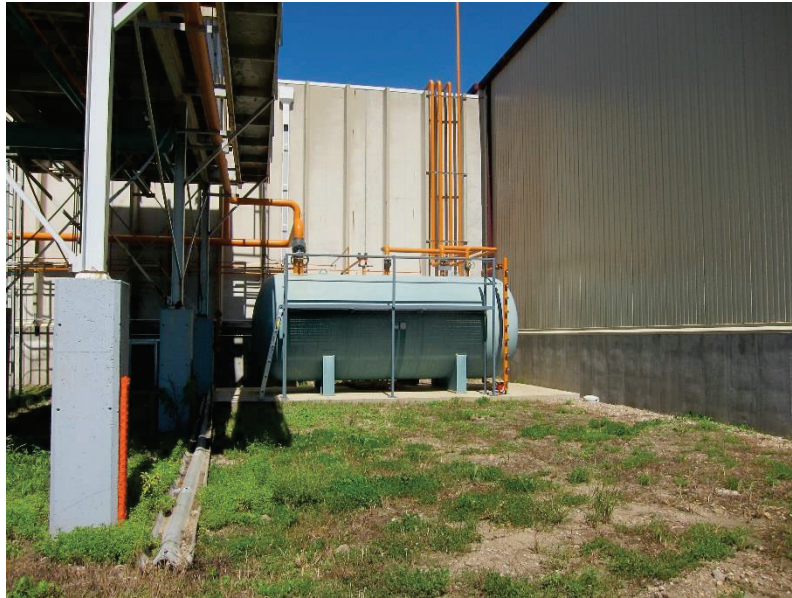
CASE NO. 15IA0909 Direction: North	DESCRIPTION	This photograph shows the high-pressure receiver of the high-side system.	10
	FACILITY	Iowa Premium – High-Side Refrigeration System	Date
	PHOTOGRAPHER	Robert Monnig	9/9/15

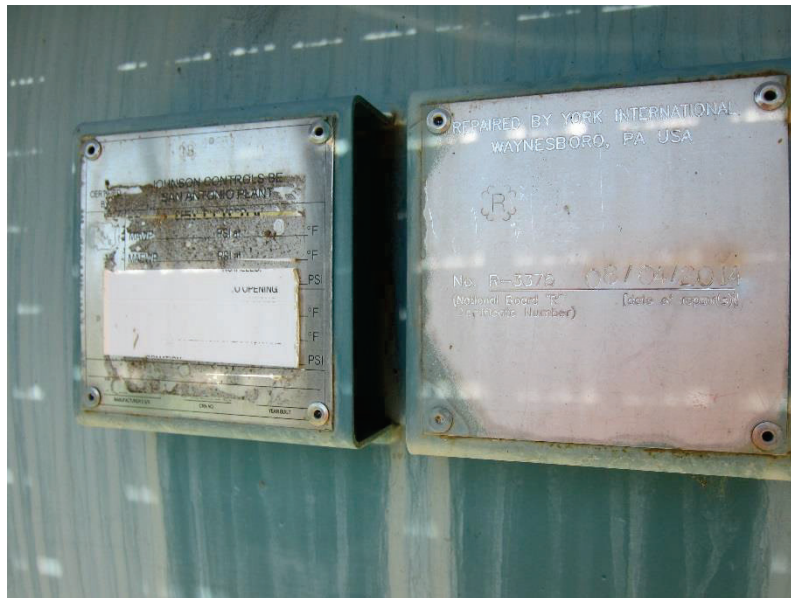
CASE NO. 15IA0909 Direction: North	DESCRIPTION	This photograph shows the data plate of the high-pressure receiver of the high-side system. The plate on the right is a repair “R” stamp plate indicating a repair date of August 4, 2014.	11
	FACILITY	Iowa Premium – High-Side Refrigeration System	Date
	PHOTOGRAPHER	Robert Monnig	9/9/15
